Ground penetrating radar investigation of the fissuring of the A690 in Houghton-le-Spring

Commissioned Report CR/03/301R

R J Cuss & G Thompson

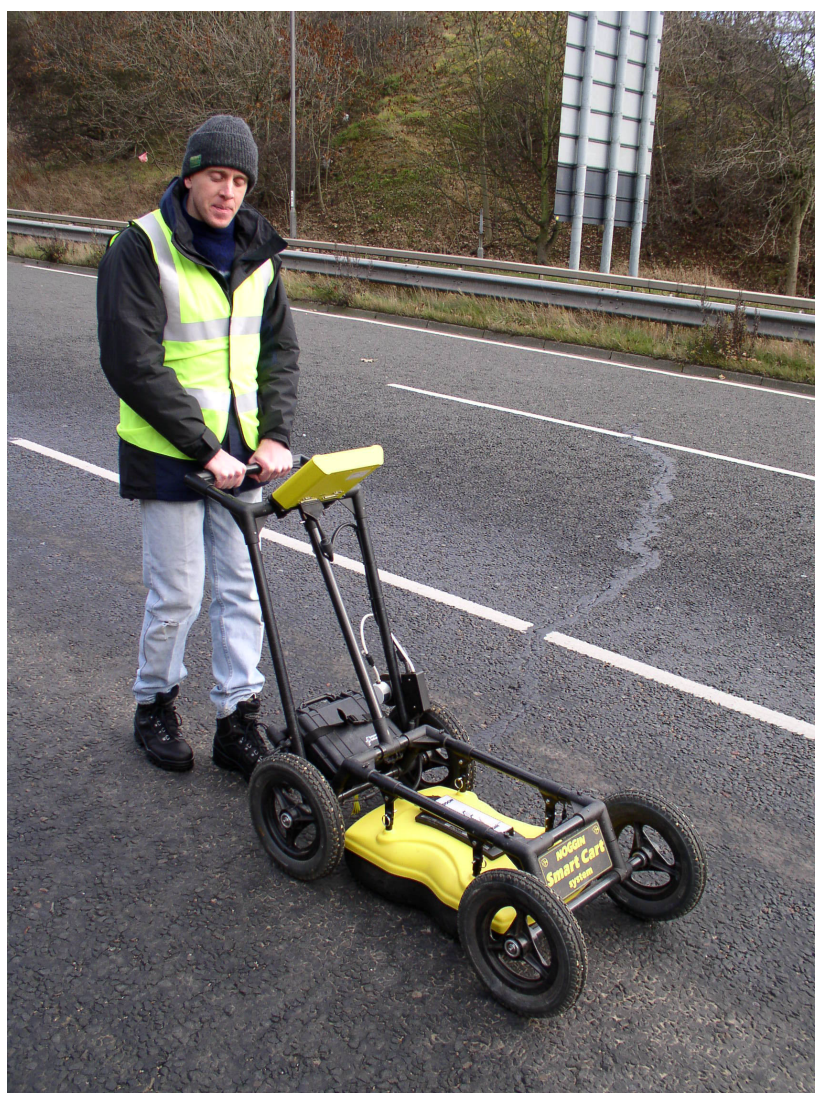
Front cover

The ground penetrating radar unit
passing over one of the surface
visible fissures in the A690.

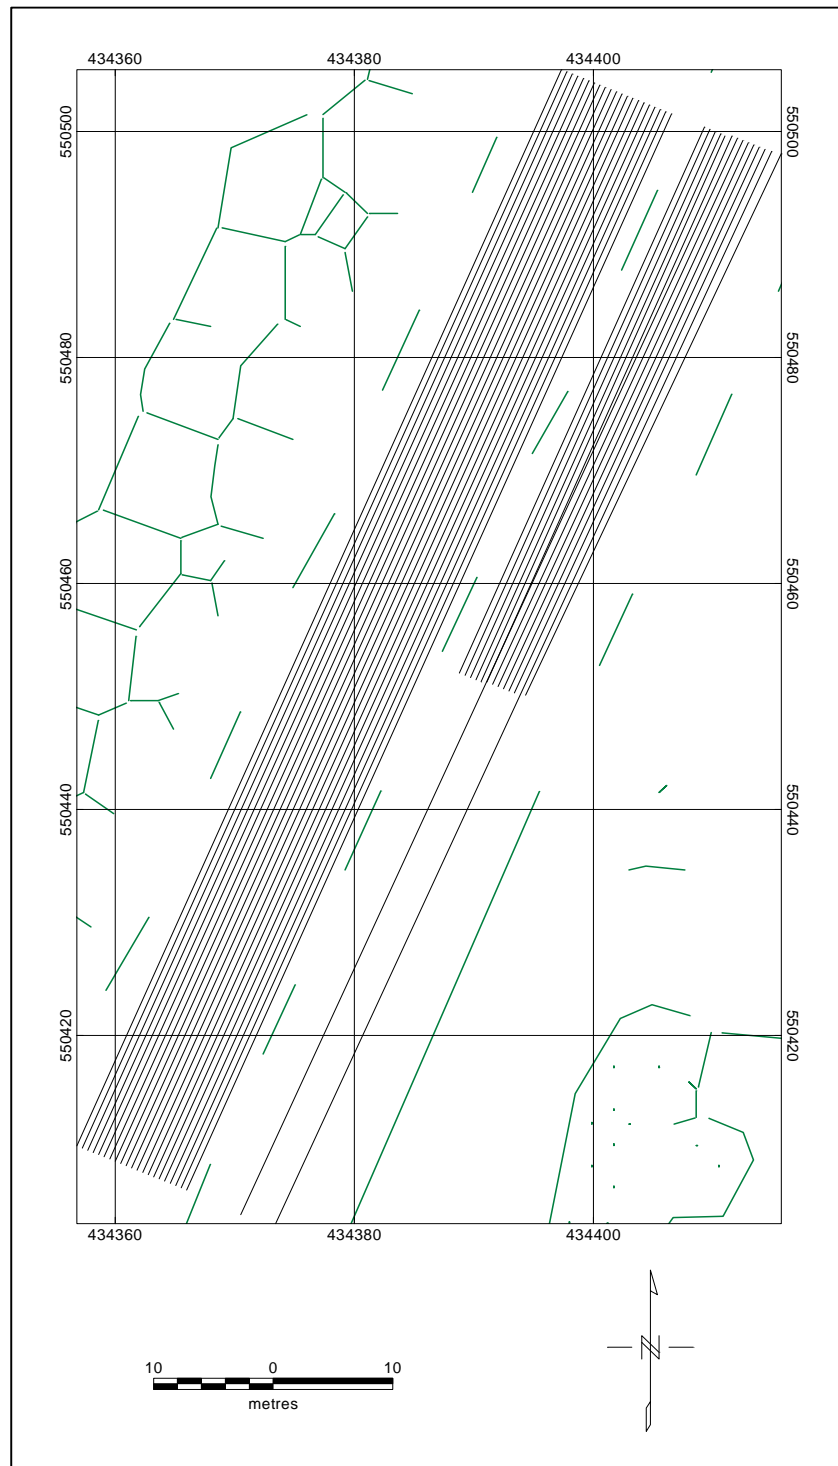
Figure 2 Location of the surveys sites on the A690 in Houghton Cut. Topography traced from OS image displayed in Figure 1.

As shown in Figure 2, two survey lines were extended to approximately 103 metres length to the south to light posts L405/L406. This would allow features identified in the northbound carriageway to be traced across the southbound carriageway. These two lines were coincident with the eighth and fourteenth lines.

As progress on the southbound carriageway survey was good, the decision to conduct a 103-metre survey along the northbound carriageway was taken. This would allow the major fissure to be examined and for another fissure to the south to be investigated. A network of 21 lines of 103-metre length was set out, separated by 0.5m parallel to the direction of the road (approximately NNE). The northern edge of the survey was delimited by light L397/L398, the south by L405/L406. This meant that the two target fissures were located at approximately 28 (as shown in Figure 4) and 64 metres along line (y-direction). The SW corner of the survey was chosen as the survey origin, with x and y distances increasing in an easterly and northerly direction respectively. Figure 2 shows the location of the survey area, which had limits as shown in Table 2.

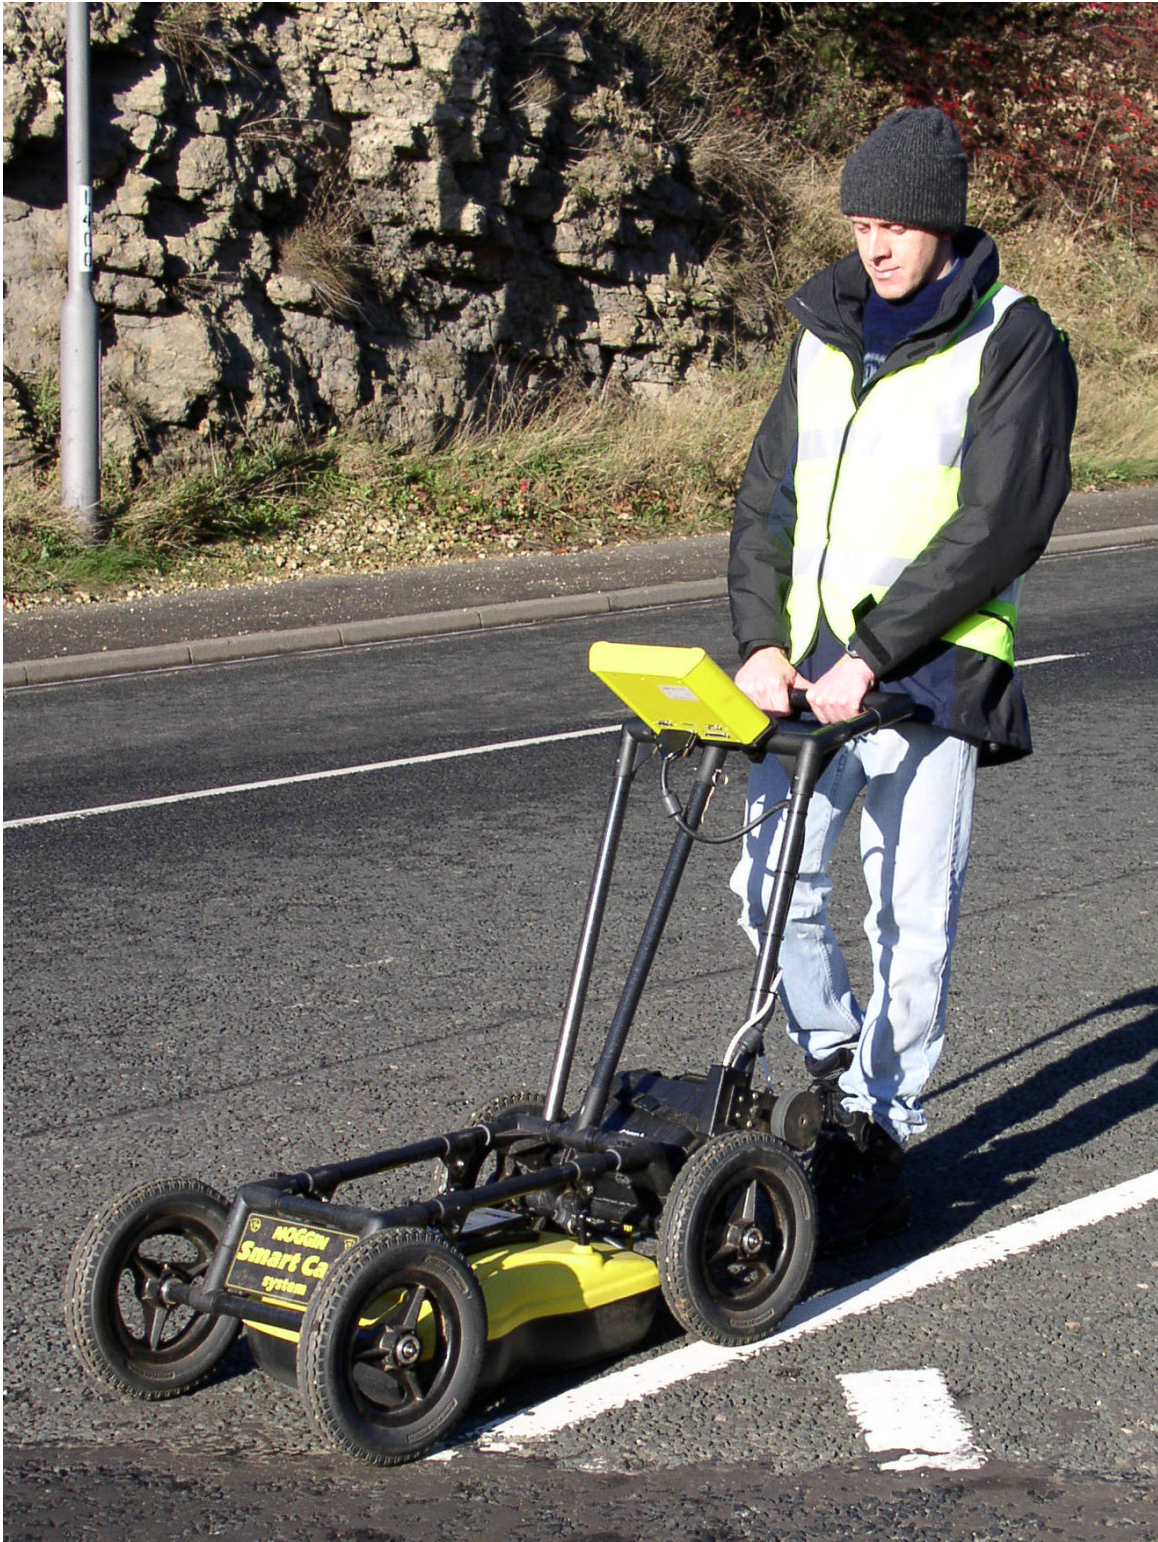
Figure 3 The geophysical equipment used in the survey. The ground penetrating radar unit is the black and yellow box seen between the wheels of the cart. This is connected to the yellow digital video logger.

The ground penetrating radar (GPR) apparatus consisted of a Noggin Smart Cart System. The Smart Cart is an integrated ground penetrating radar acquisition platform. The complete system comprises the cart, a Noggin antenna, an odometer wheel, a digital video logger (DVL), and a battery. Figure 3 shows the Noggin Smart Cart at the Houghton site. The DVL gives the operator an instant display of GPR signal, allowing the survey to be modified if necessary.

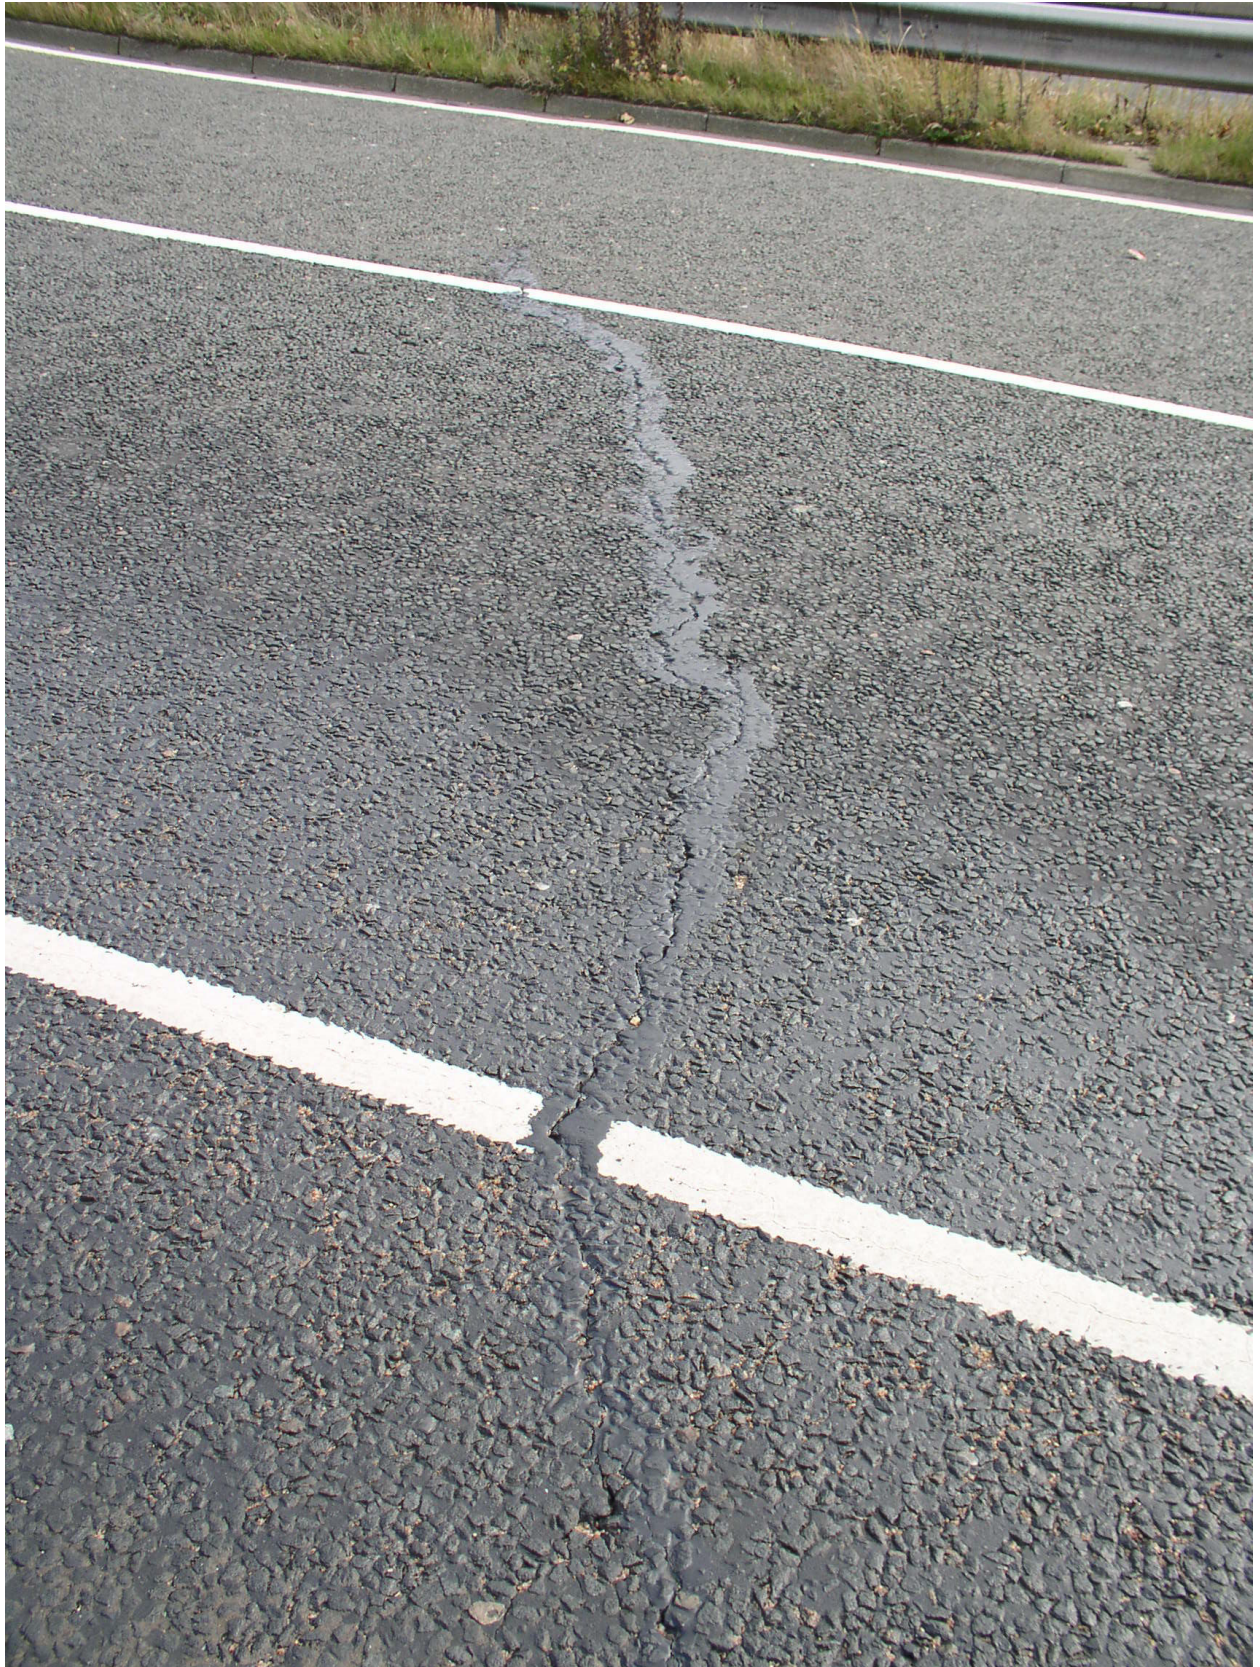
Figure 4 Fissure seen in the surface of the northbound carriageway of the A690, note that the fissure is not a perfectly linear feature. This is feature H shown in Figure 9.

The southern fissure (Feature H, Figure 9), which also has a surface expression as shown in Figure 4, is identified across the entire carriageway, although the character of the GPR results changes across the road. This bright feature is smaller in extent than the major fissure, but gives very strong reflections from about 1 metre depth and below. This suggests that this fissure is extensive and could be open. As the character of this fissure changes across the road, it is suggested that the fissure may be open by a differing amount across the carriageway.

The fissure that is identified as a clear crack in the road surface (Figure 4) was identified in the GPR results of May 2002. Comparing the data of 2002 and 2003 clearly shows that the latter survey has a significant reflection from this fissure, whereas only a moderately weak reflection was seen in 2002. This indicates that this fissure has become a more substantial feature in the intervening time. However, the character of the fissure feature identified in the 2003 data does change in character across the road and any differences in radar response may derive from any slight misalignment of the survey lines.

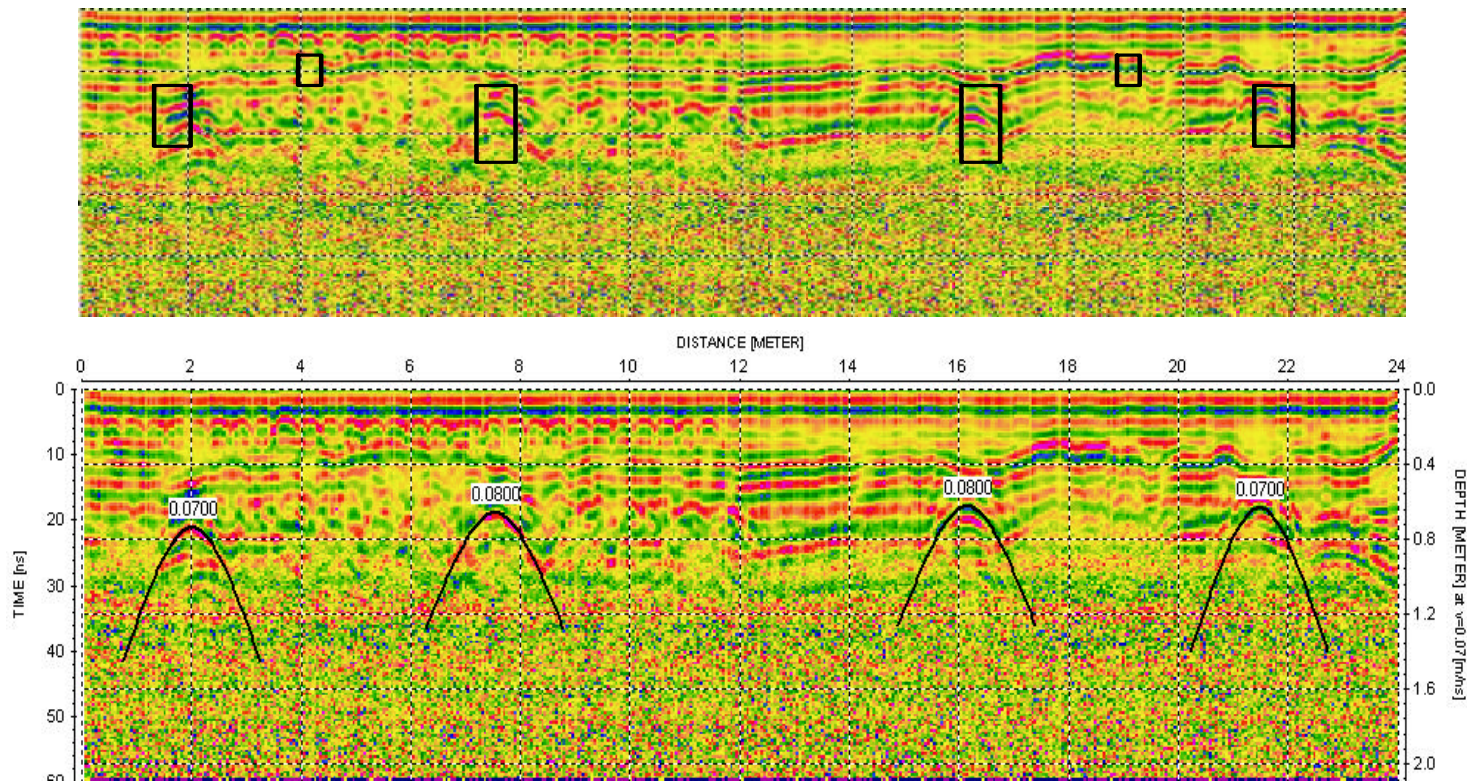
Void detection with Noggin 250 Mhz along TRL test track

Concrete surface (0-240mm), Sub-base (limestone aggregate, 200-250 mm) on London Clay. Rebar in concrete from 0 to 12 m.

Smaller voids (thickness of 200 mm) not detected

Figure 6 Results from the TRL survey showing the response of voids within a road structure. Note that the GPR unit does not detect smaller voids.

Since the survey of May 2002, the British Geological Survey has had the opportunity to test some of its geophysical equipment at the Transport Research Laboratory (TRL). Our work at TRL allowed a GPR survey to be conducted over known synthetically created voids of defined location. Figure 6 shows that voids within a road structure are identified by hyperbolae diffraction centred on either the roof or floor of the void. This data shows that smaller voids, 200 mm, did not show any GPR response. Thus any detected hyperbolae will have been formed by fissures open more than this amount. However, fissures are extensive features that continue for several metres or more. This lateral extent will mean that fissures with less opening than 200 mm will be detected.
